National Transportation Safety Board

WPR20LA283

AIRWORTHINESS

Group Chair's Factual Report

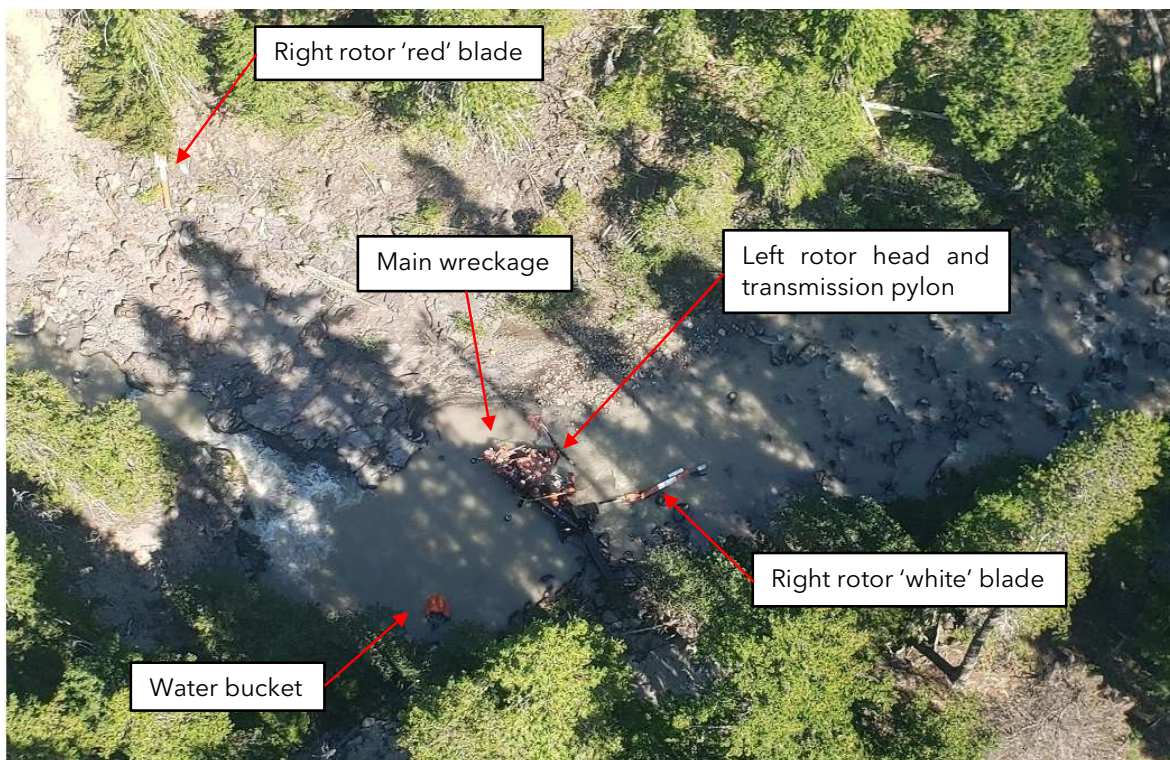
The entirety of the airframe was found at the accident site and there was no evidence of an inflight fuselage breakup (**Figure 1**). The helicopter came to rest on its right side (**Figure 2**). The nose of the helicopter had crushed aft and inward. The tail boom exhibited deformation on its underside immediately aft of the horizontal stabilizer resulting in the aft portion of the tail boom being bent downward. The main and nose landing gears remained installed. The left horizontal stabilizer remained installed, and the right horizontal stabilizer had fractured and separated but was

Figure 1. An aerial view of the accident site. (Image provided by Central Copters and edited by the NTSB.)

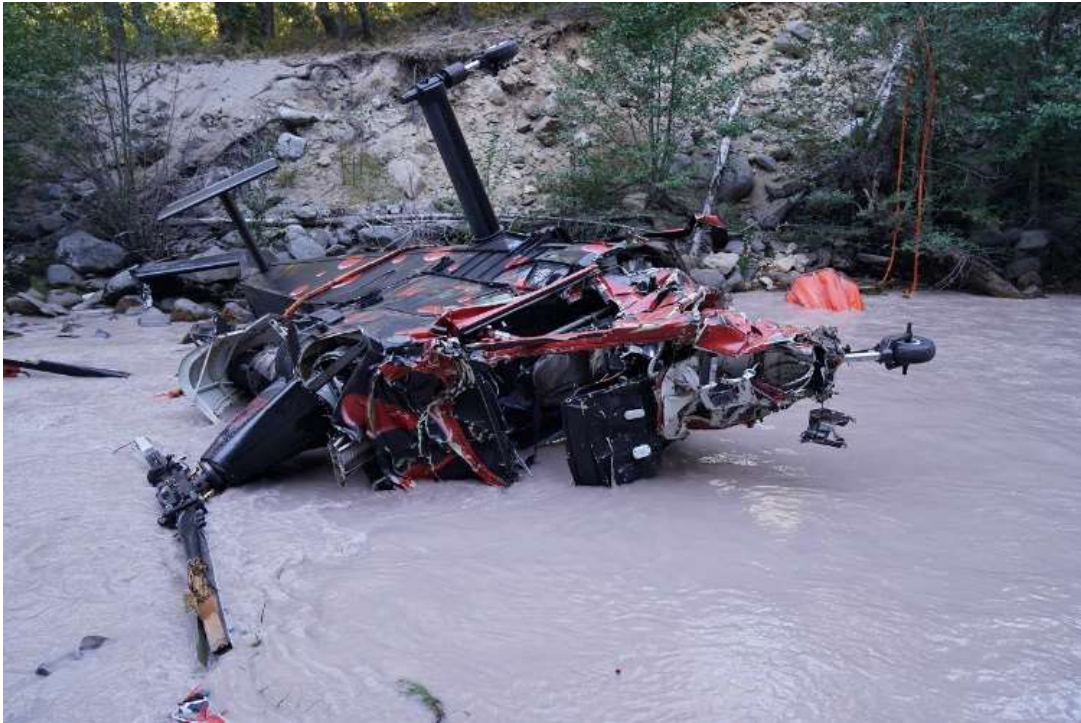
Figure 2. The fuselage at the accident site. (Image provided by Central Copters.)

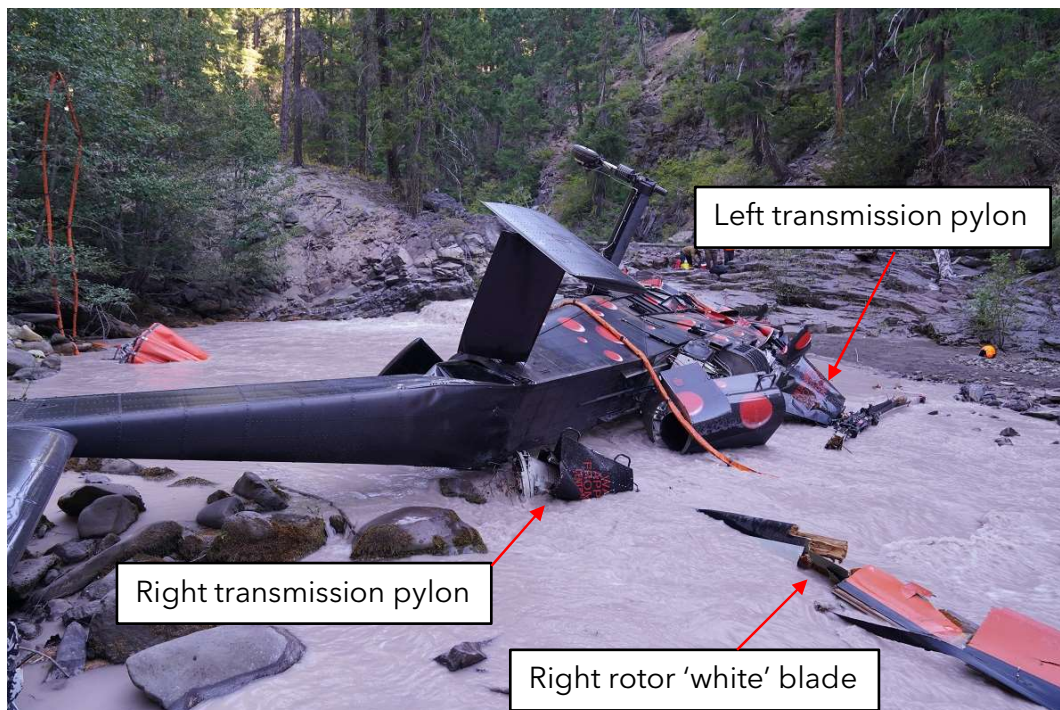
Figure 3. The separated transmission pylons at the accident site. (Image provided by Central Copters.)

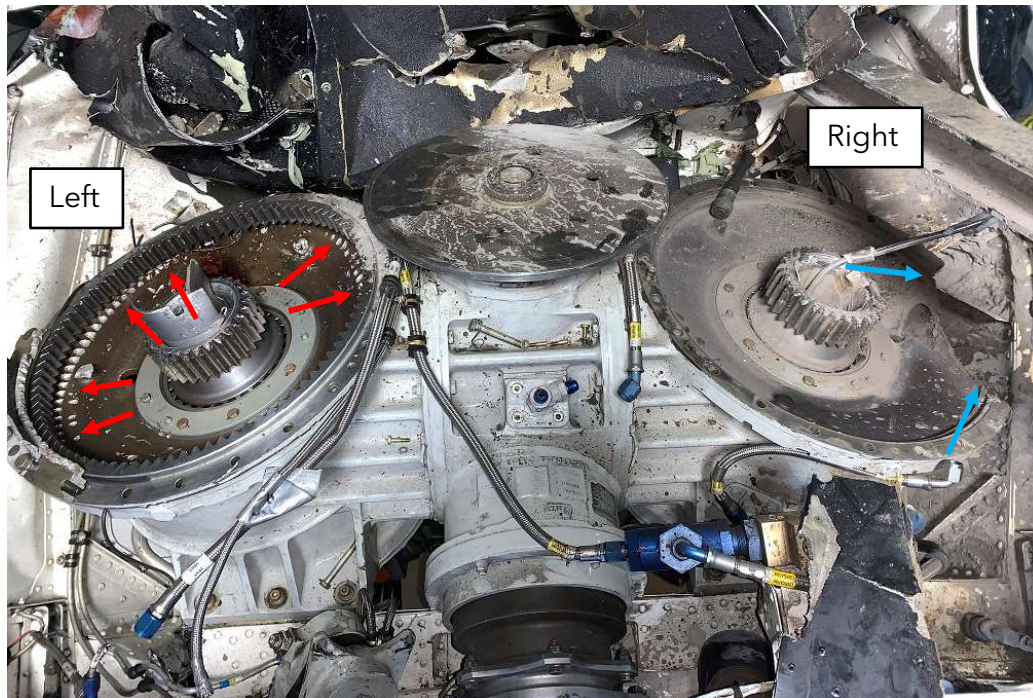
Figure 4. The main transmission center housing with the left and right sun gears. Aircraft forward is to the top of this image. The red arrows show the arcs of gear teeth impressions and the blue arrows show the fractures on the lower housing.

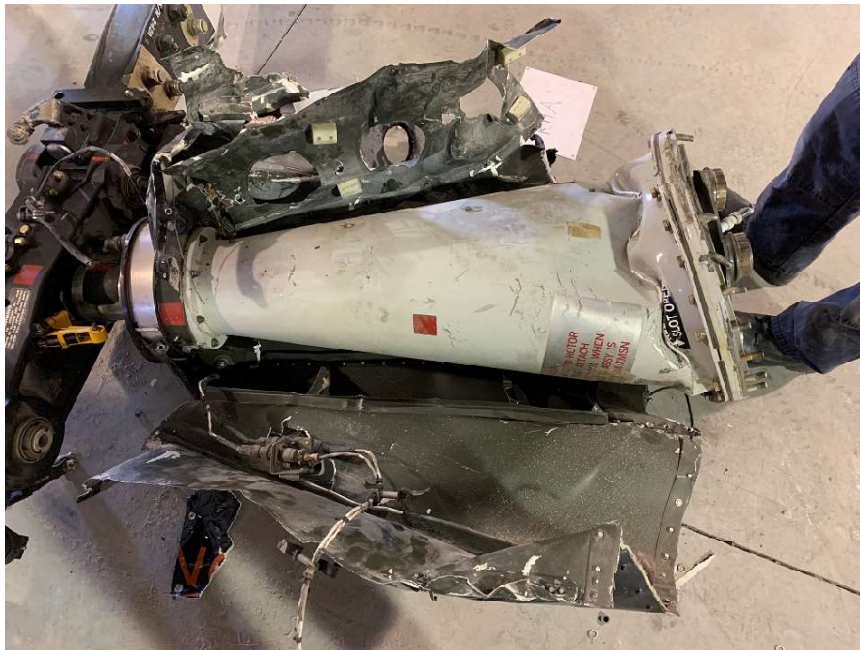
The right transmission pylon housing exhibited deformation on its forward side such that the housing was bent forward (**Figure 5**). The aft side of the attachment flange, attaching the conical housing to the ring gear and the right-side lower housing, was bent upward and had partially lifted off. The right-side planetary carrier remained installed within the right transmission pylon and attached to its rotor shaft, but none of its five planetary gears were present. Three of the five planetary gear bearings remained installed on the planetary carrier while two of the five bearings were not present. The rotor shaft remained connected to the right rotor head via the teetering bolt. The center strap fitting, normally installed between the upper ends of the left and right transmission pylons, remained attached to the right transmission pylon but was fractured and separated from the left transmission pylon (**Figure 6**).

Figure 5. The right transmission pylon showing deformation of the housing.

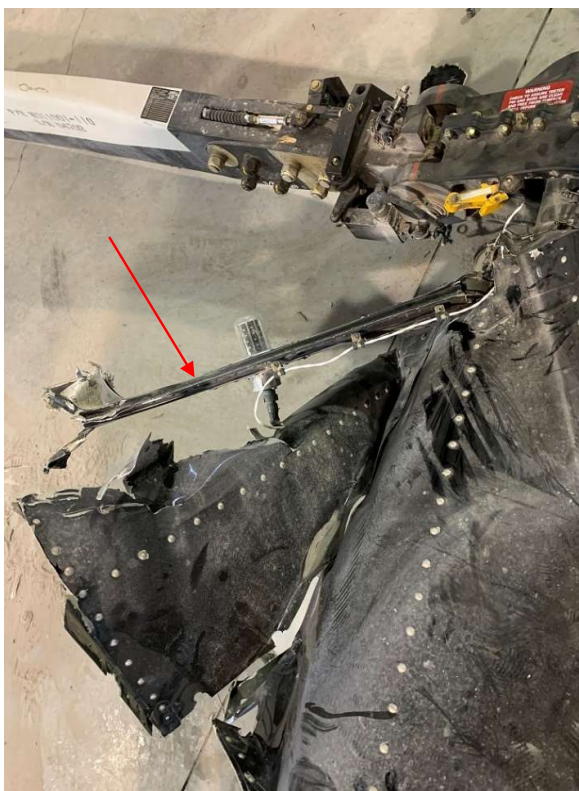
Figure 6. The right transmission pylon and center strap fitting (red arrow).

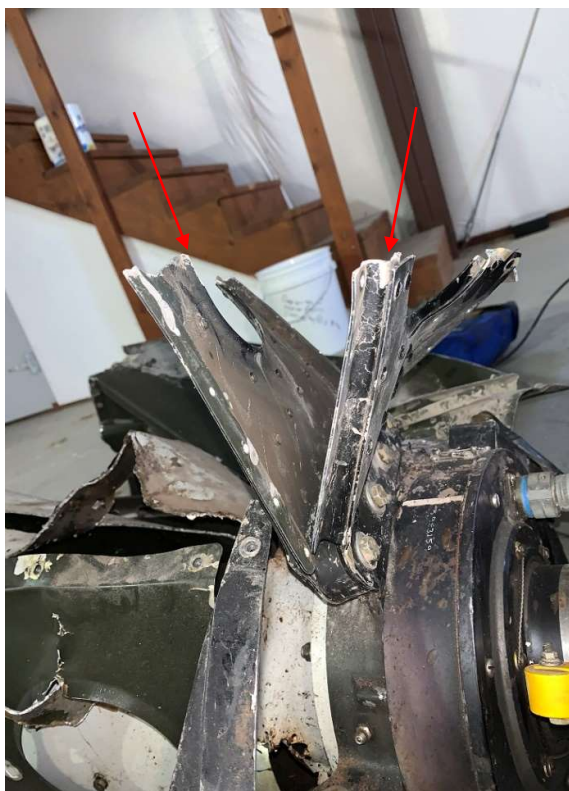
The left transmission pylon housing exhibited minor deformation on its aft side. A small portion of the center strap fitting remained attached to the left transmission pylon (**Figure 7**). The right side of the conical housing had two parallel vertical cracks that extended about two-thirds of the height of the housing (**Figure 8**). The housing material between these two cracks had bulged outward near its upper side. The left-side planetary carrier remained installed within the left transmission pylon and attached to its rotor shaft. Four of the five planetary gears remained installed on the carrier, with the fifth planetary gear and its bearing separated from the carrier. The rotor shaft remained connected to the left rotor head via the teetering bolt.

Figure 7. The left transmission pylon and center strap fitting (red arrows).

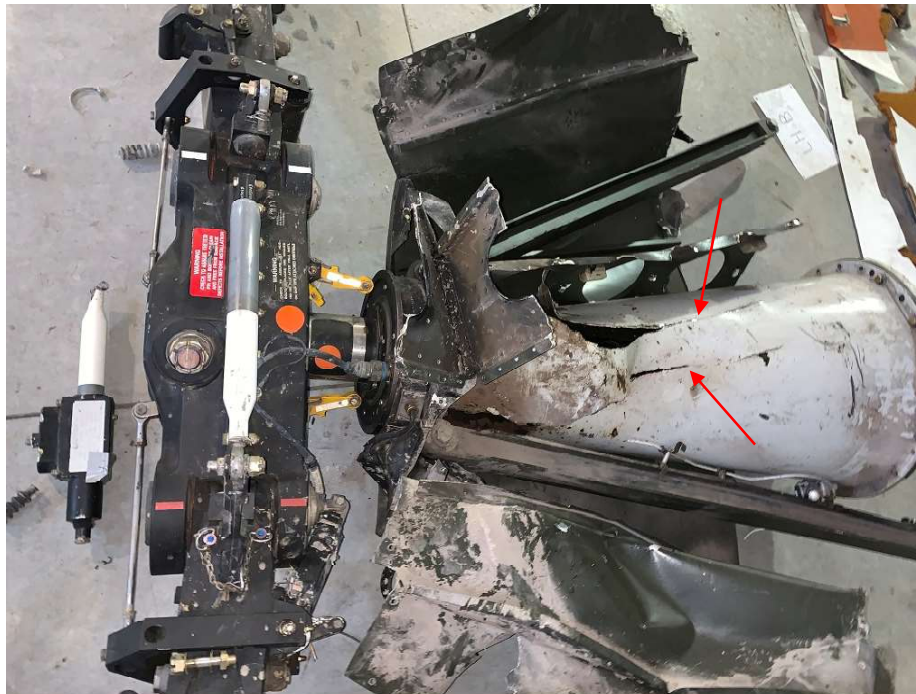
Figure 8. The left transmission pylon and rotor head. The two cracks extending vertically up the housing are identified with red arrows.

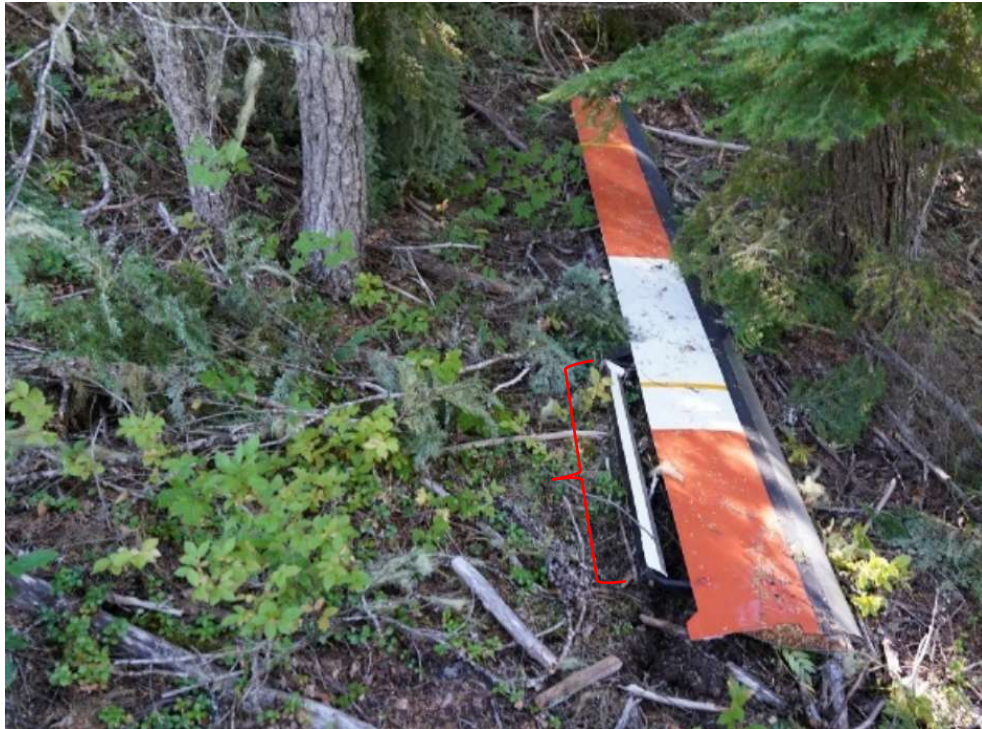
The 'white' blade (S/N 473A) had fractured and separated in the vicinity of three RSTA locations: RSTA 77, RSTA 232, and RSTA 260. The majority of the 'white' blade pieces was found grouped together about 560 feet away from the main wreckage in a wooded area (**Figure 9**). The tip section of the 'white' blade exhibited fragmentation and its leading edge exhibited significant deformation in multiple locations (**Figure 10**). The servo flap spar remained installed on the 'white' blade but the servo flap afterbody had completely fractured and separated from the spar and was found about 192 feet away from the main wreckage (**Figure 11**). Both the upper and lower fractures of the servo flap afterbody were nearly straight in the spanwise direction. The servo flap inboard bracket exhibited a large area of contact damage on its outboard side as well as evidence of contact with the chordwise servo flap control rod bolt head (**Figure 12**). The servo flap outboard bracket was undamaged. The inboard section of the 'white' blade remained attached to its rotor head grip. The leading edge of the inboard section (still attached to the rotor head grip) exhibited impact marks and spanwise fragmentation along the spar (**Figures 13 and 14**).

Figure 9. The left rotor 'white' blade as found about 560 feet away from the main wreckage. The red bracket identifies the servo flap spar that remained attached. (Image provided by Central Copters.)

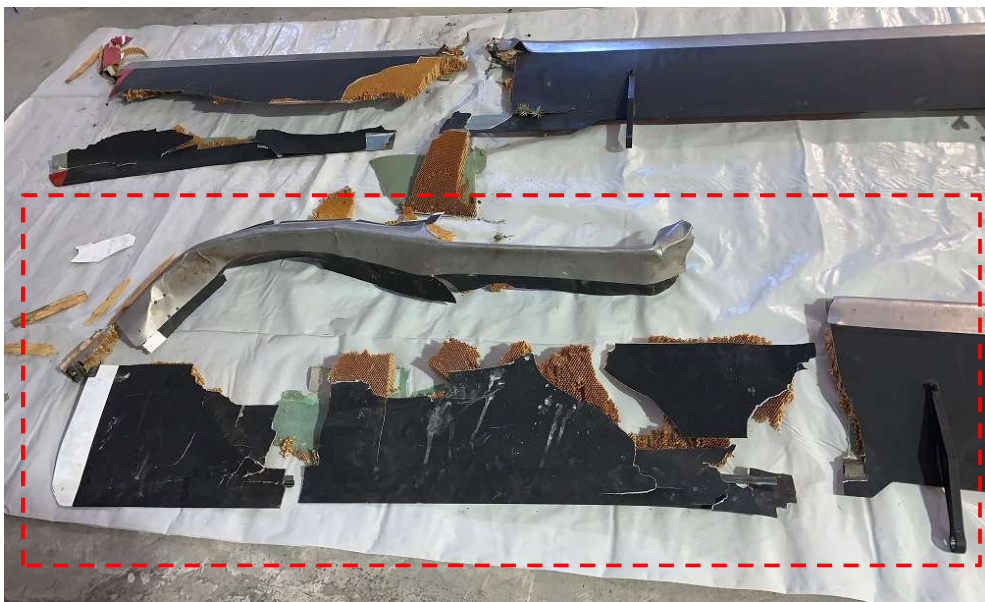
Figure 10. The reconstructed tip section of the left rotor 'white' blade is seen in the red box, with the reconstructed tip section of the 'red' blade seen above.

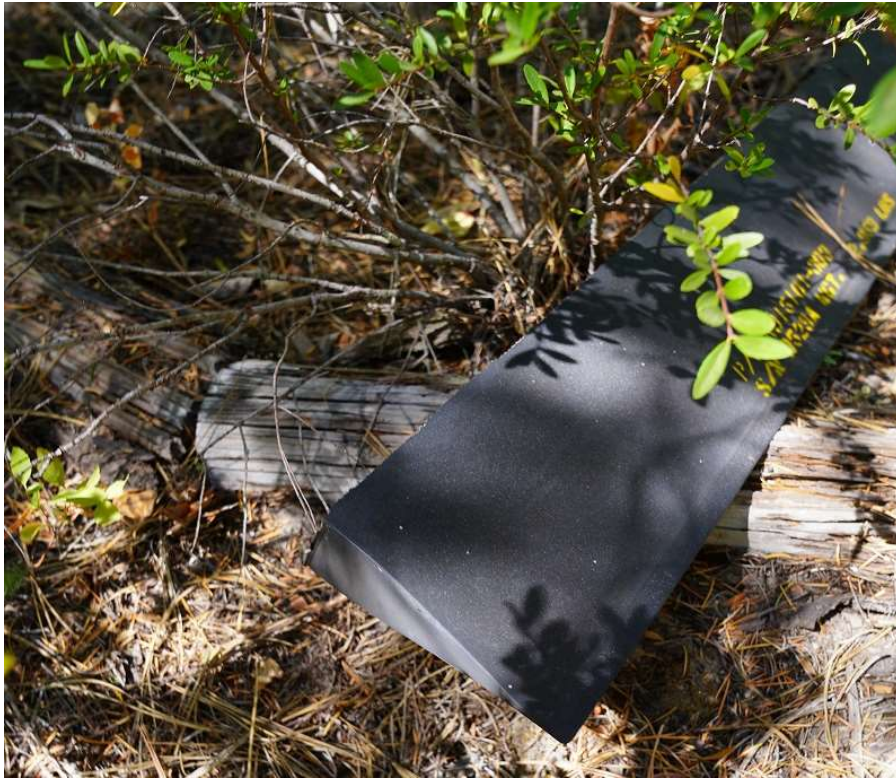
Figure 11. The separated servo flap afterbody found about 192 feet away from the main wreckage. (Image provided by Central Copters.)

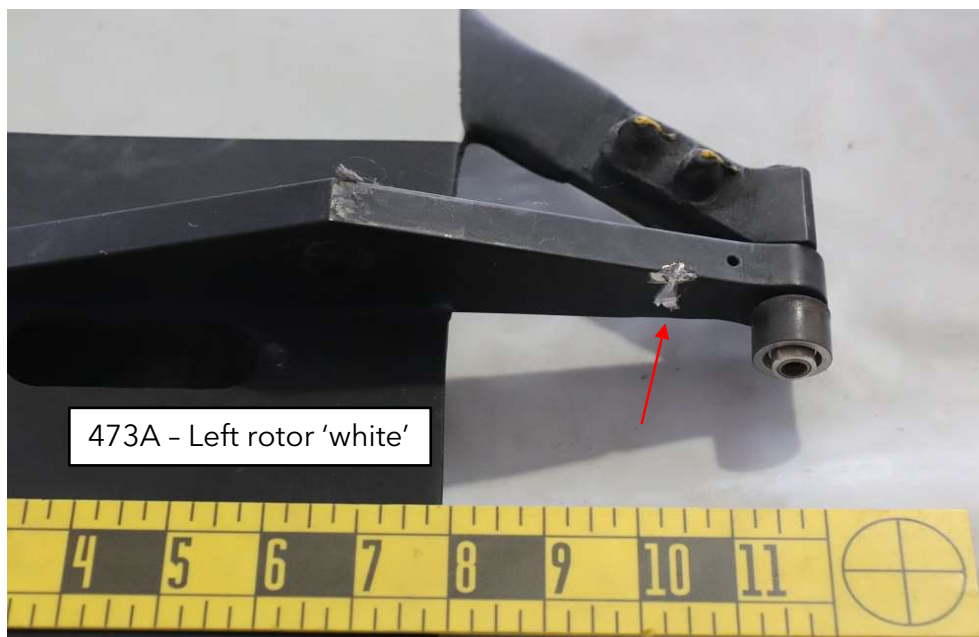
Figure 12. Contact damage (red arrow) observed on the outboard side of the inboard servo flap bracket of the left rotor 'white' blade.

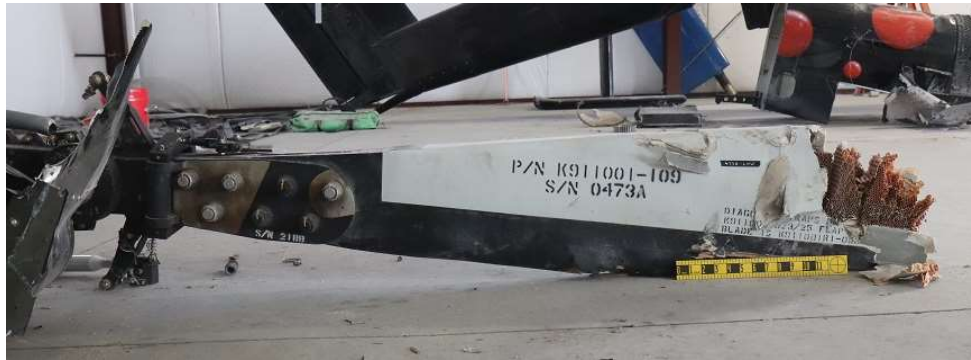
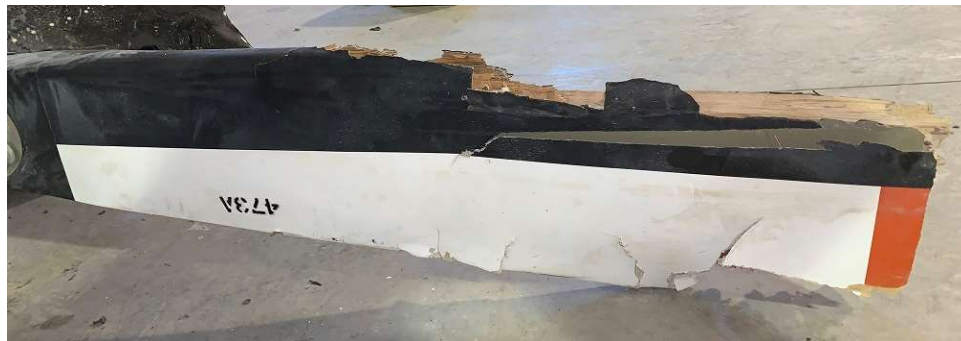
Figure 13. The lower surface of the inboard section of the left rotor 'white' blade.

Figure 14. The upper surface of the inboard section of the left rotor 'white' blade.

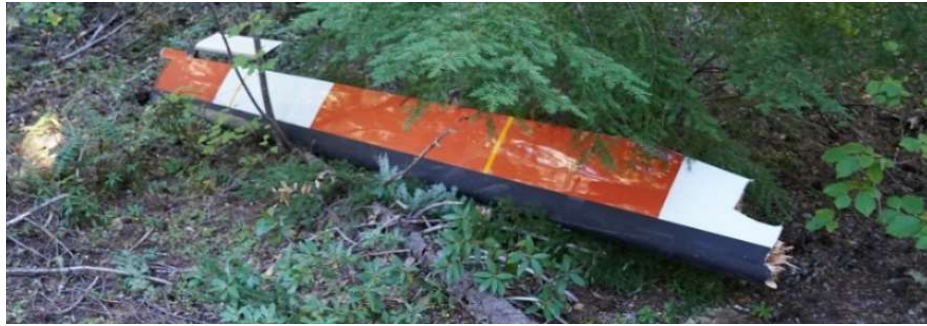
The 'red' blade (S/N 473B) had fractured and separated in the vicinity of two RSTA locations: RSTA 48 and RSTA 245. The bulk of the 'red' blade was found about 500 feet away from the main wreckage, with the tip section found about 570 feet away in a wooded area (**Figure 15**). On the tip section of the 'red' blade, the tip cap and a portion of the afterbody had separated. On the inboard side of the RSTA 245 fracture, the leading edge abrasion strip and weight exhibited deformation in the direction opposite of normal rotation. The servo flap was whole and remained installed on the 'red' blade. The servo flap inboard bracket exhibited an area of moderate contact damage on its outboard side as well as evidence of contact with the chordwise servo flap control rod bolt head (**Figure 16**). The servo flap outboard bracket was undamaged. On the underside of the blade, between the blade fracture at RSTA 48 and RSTA 83.5, a dark colored contact mark, similar in color to the leading edge coating of the rotor blades, as well as impacted spar, core, and skin, were observed (**Figure 17**). At the inboard side of the fracture at RSTA 48, the lower trailing edge corner exhibited a blunted impact mark (**Figure 18**). The inboard section of the blade remained attached to its rotor head grip.

Figure 15. The left rotor 'red' blade as found about 570 feet away from the main wreckage. (Image provided by Central Copters.)

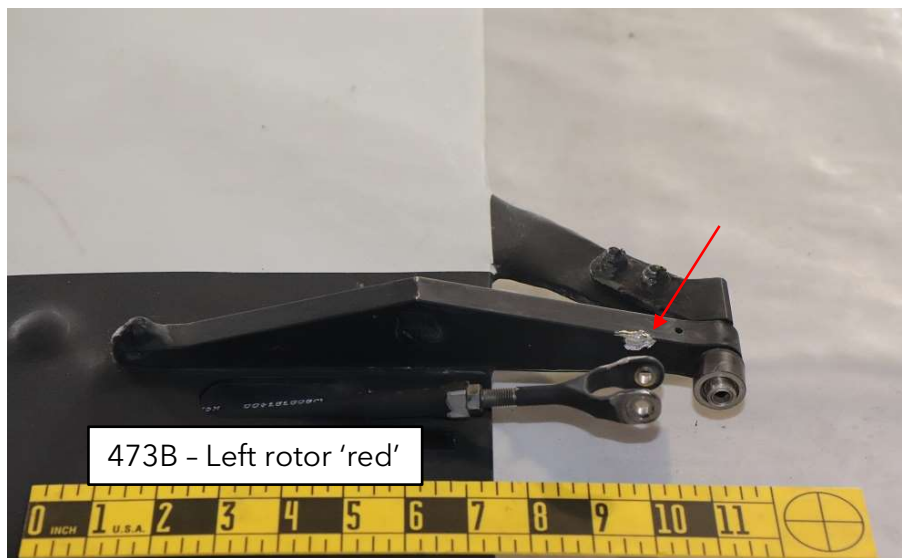
Figure 16. Contact damage (red arrow) observed on the outboard side of the inboard servo flap bracket of the left rotor 'red' blade.

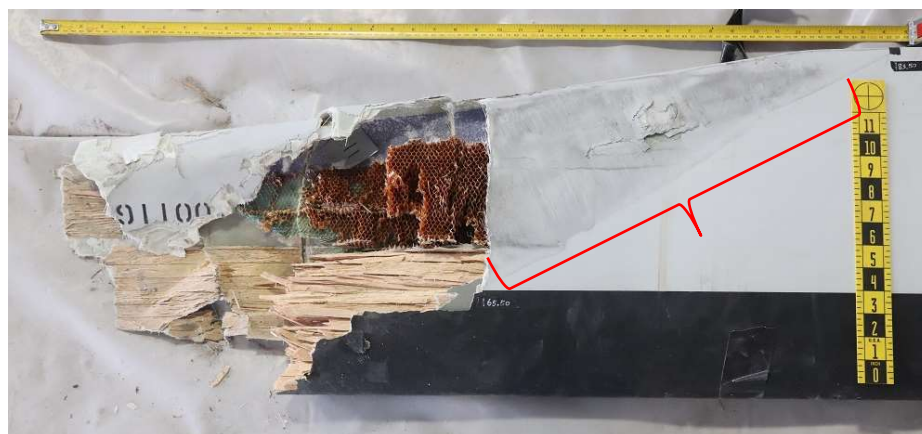
Figure 17. The inboard fracture of the left rotor 'red' blade with the skin exhibiting an area of contact, identified by the red bracket, that is dark in color.

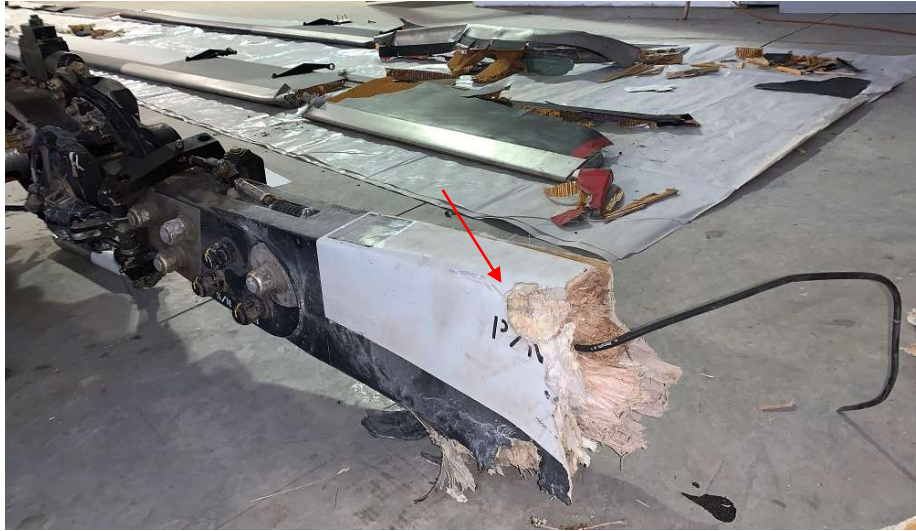
Figure 18. The inboard section of the left rotor 'red' blade. The red arrow points to the blunted impact mark.

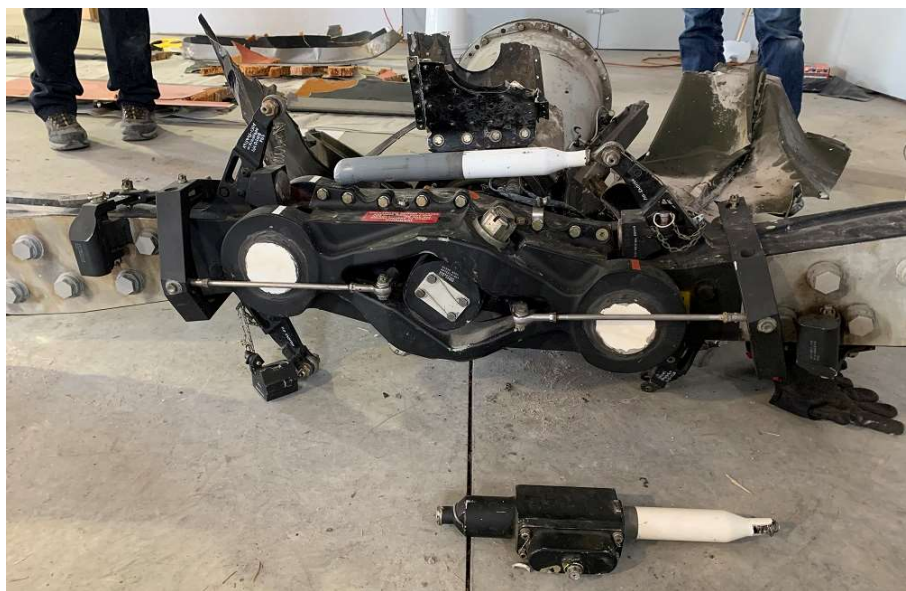
For the blade lead-lag damper between the leading (advancing) side of the 'red' blade and the lagging (trailing) side of the 'white' blade, only the damper piston was present and the damper housing was not recovered. The damper piston and its rod end remained attached to the 'red' blade leading side damper attachment horn (**Figure 19**). The damper piston did not exhibit significant bending deformation. The damper housing's rod end remained installed on the 'white' blade lagging side damper attachment horn. The two damper attachment horns did not exhibit significant deformation.

On the opposite side of the rotor head, the blade lead-lag damper was found about 86 feet away from the main wreckage. The rod ends of both damper piston and housing remained attached to the 'white' blade leading side damper horn and the 'red' blade lagging side damper horn, respectively. The damper piston-side attachment horn did not exhibit significant deformation. The damper housing-side attachment horn exhibited a slight downward deformation.

Figure 19. The lead-lag damper remnants for the left rotor system.

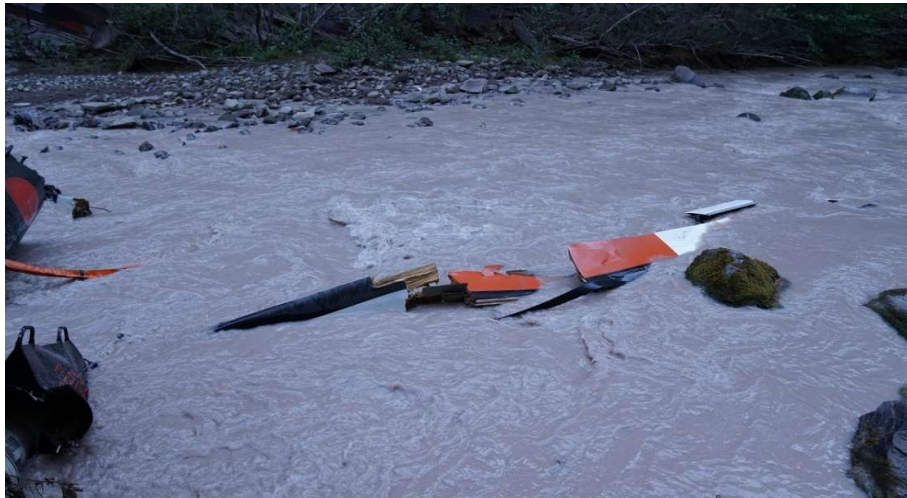
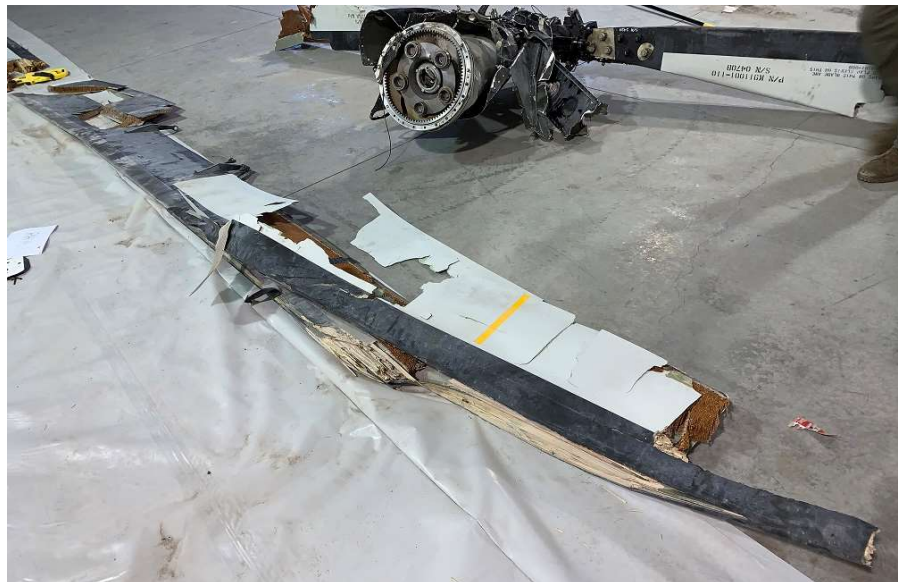
RSTA 118, RSTA 183, and RSTA 233. The bulk of the 'white' blade was found adjacent to the main wreckage near the tail boom (**Figures 20 and 21**). The after body of the tip end of the 'white' blade was found about 180 feet downstream from the main wreckage. The servo flap was whole and remained installed on the 'white' blade. The servo flap inboard bracket exhibited a small area of contact damage on its outboard side as well as evidence of contact with the chordwise servo flap control rod bolt head (**Figure 22**). The servo flap outboard bracket was undamaged. The inboard section of the 'white' blade remained attached to its rotor head grip (**Figure 23**). The 'white' blade was separated from its hub to facilitate its recovery.

Figure 20. The right rotor 'white' blade at the accident site. (Image provided by Central Copters.)

Figure 21. The recovered right rotor 'white' blade.

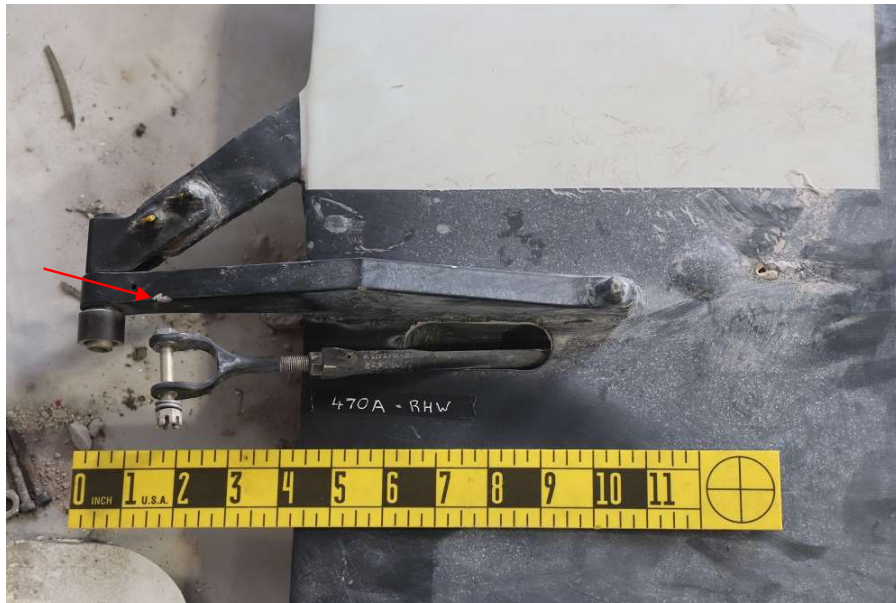
Figure 22. Contact damage (red arrow) observed on the outboard side of the inboard servo flap bracket of the right rotor 'white' blade.

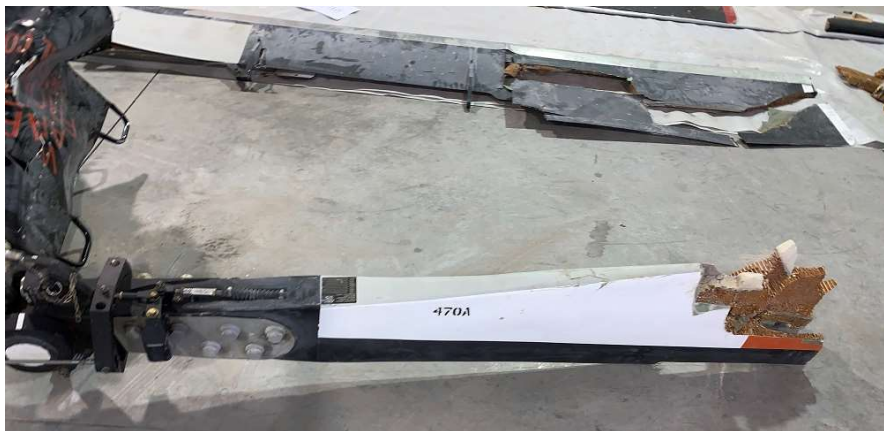
Figure 23. The inboard section of the right rotor 'white' blade.

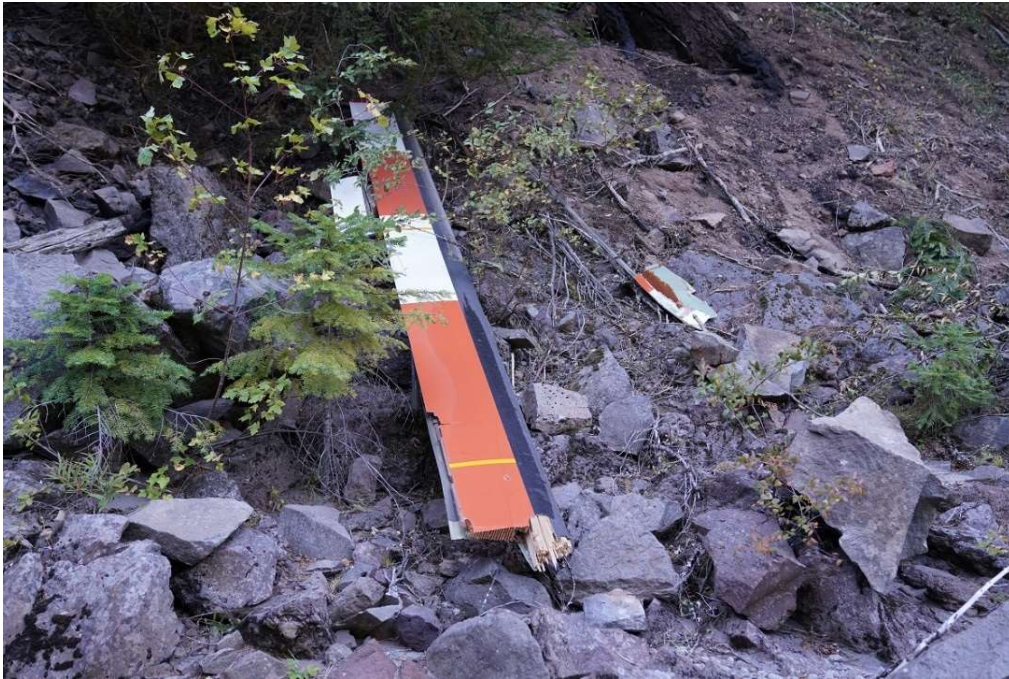
The 'red' blade (S/N 470B) had fractured and separated in the vicinity of RSTA 94. The bulk of the 'red' blade was found about 81 feet away from the main wreckage (**Figure 24**). The servo flap was whole and remained installed on the 'red' blade. The servo flap inboard bracket exhibited a small area of contact damage on its outboard side as well as evidence of contact with the chordwise servo flap control rod bolt head (**Figure 25**). The servo flap outboard bracket was undamaged. The inboard section of the 'red' blade remained attached to its rotor head grip (**Figure 26**).

**Figure 24. The right rotor 'red' blade about 81 ft away from the main wreckage.
(Image provided by Central Copters.)**

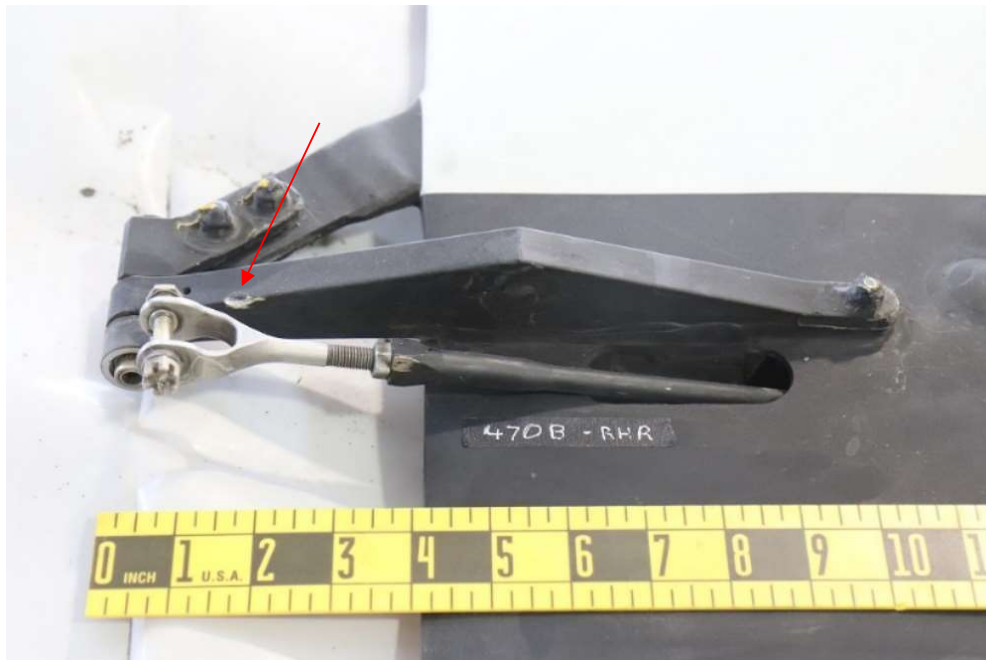
**Figure 25. Contact damage (red arrow) observed on the outboard side of the
inboard servo flap bracket of the right rotor 'red' blade.**

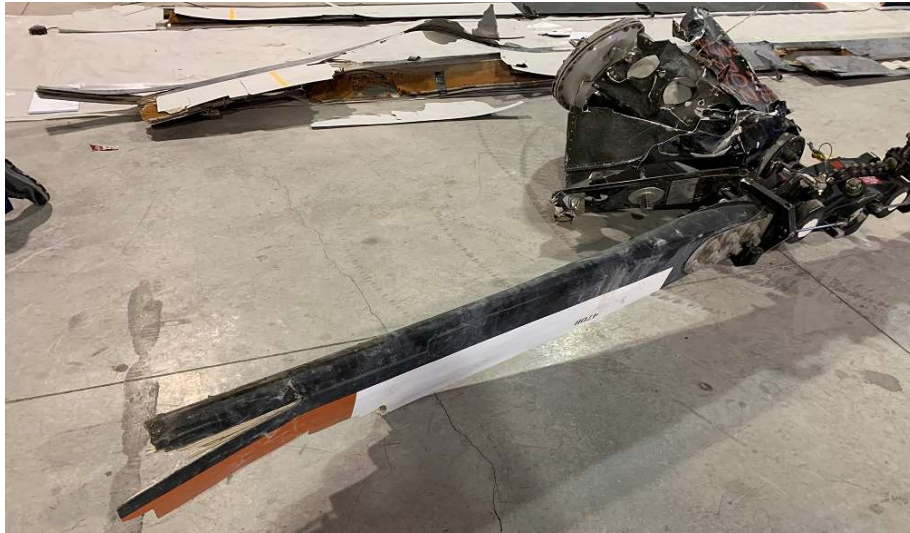
Figure 26. The inboard section of the right rotor 'white' blade.

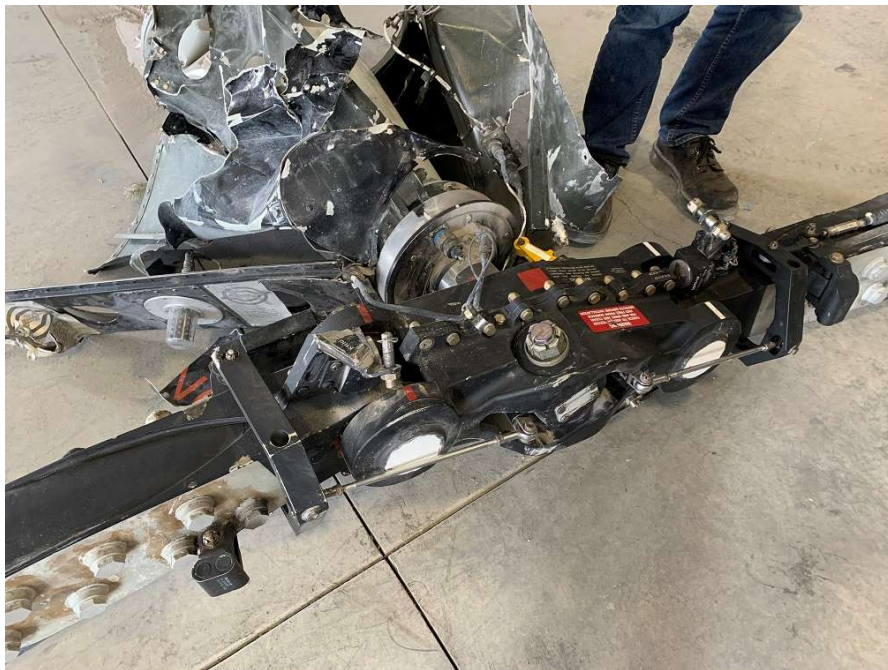
Both blade dampers had fractured and separated, and neither damper was found and recovered (**Figure 27**). For the damper between the 'white' blade leading side and 'red' blade lagging side, both rod ends remained attached to their respective damper attachment horns. The 'white' blade leading side damper attachment horn did not exhibit significant deformation. The 'red' blade lagging side damper attachment horn had deformed downward.

Figure 27. The right rotor head with neither damper present.

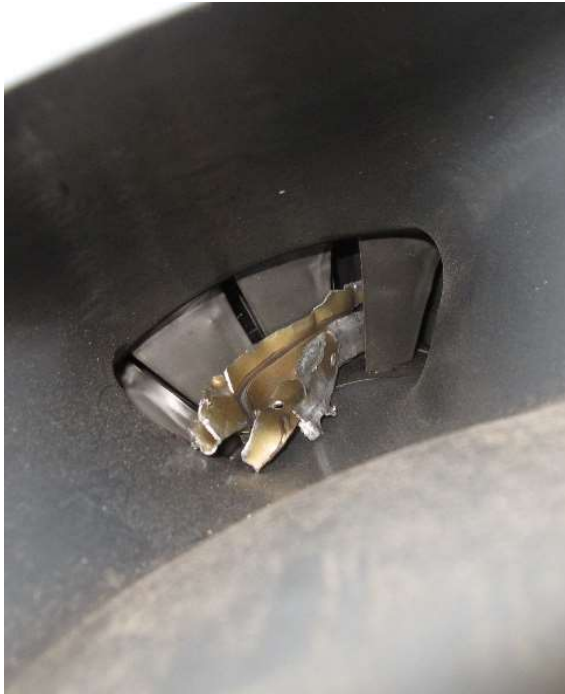
Looking through the inlet, debris had been ingested into the engine and all the variable inlet guide vanes (IGV) appeared to be present and exhibited some impact damage (**Figures 28 and 29**). Looking through the exhaust diffuser, the exhaust thermocouple probes, the stage 2 PT rotor as well as the trailing edges (TE) of the stage 2 PT nozzle vanes were visible. All of the stage 2 PT blades were present, intact, and appeared undamaged, all six thermocouple probes were present, full length, and appeared undamaged, and the suction side of the stage 2 PT nozzle airfoils were covered in metal spray. Reaching through the exhaust diffuser, the N2 rotor system (PT-to-reduction gearbox-to-output shaft) would not rotate by hand. With the starter already removed, continuity was confirmed between the accessory

Figure 28. Debris observed within the inlet.

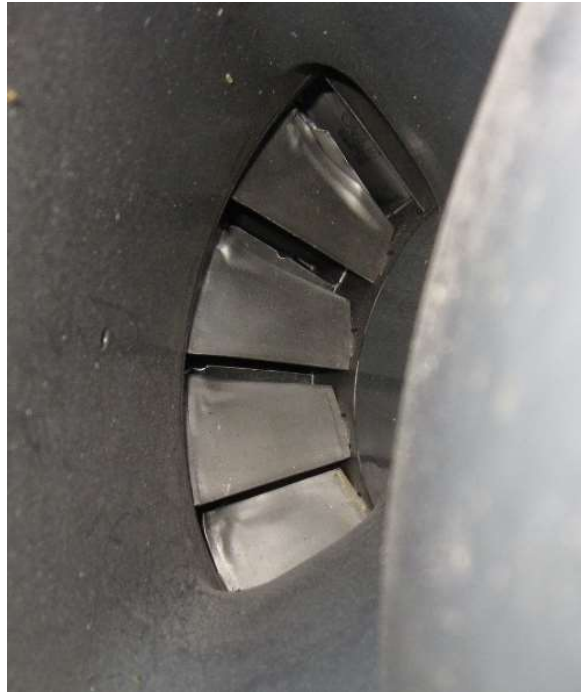
Figure 29. Damage observed on the variable inlet guide vanes.

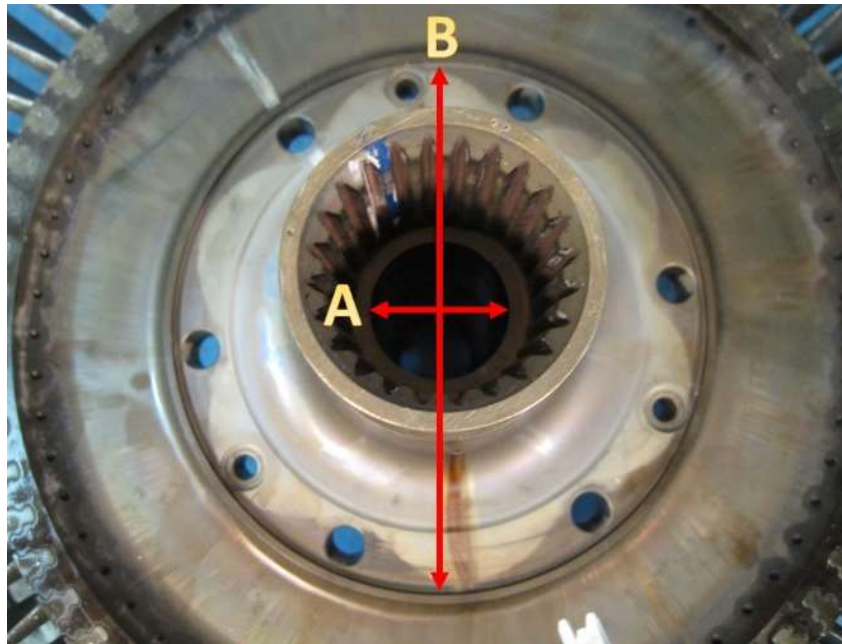
The PT stage 2 rotor disk, P/N 1-140-272-04 and S/N 971365104097, was measured for growth. The print dimension for the bore diameter is 1.188 to 1.186-inches; the bore measured 1.1875-inches (**diameter 'A' in Figure 30**). The print dimension for the snap diameter is 4.980 to 4.982-inches; the snap diameter measured 4.980-inches (**diameter 'B' in Figure 30**). Additional measurements of the PT stage 2 rotor airfoils showed no significant permanent strain was present in the airfoil.

Figure 30. Stage 2 PT disk growth measurements.

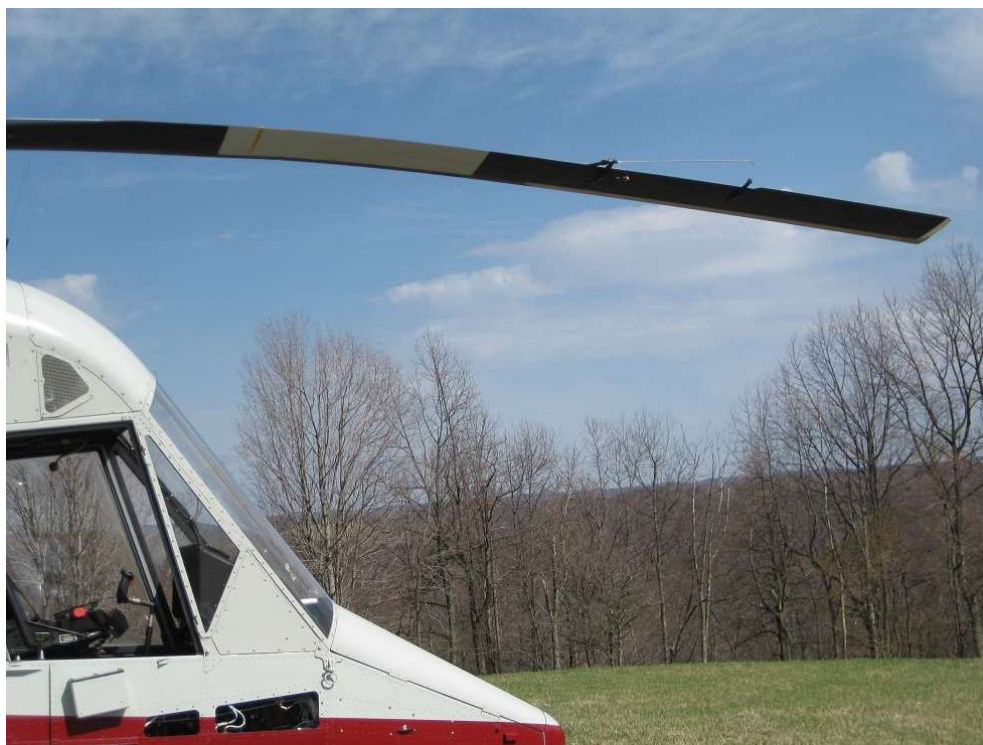
Kaman received a report in April 2009 involving the accident helicopter⁸ in which the servo flap of the left rotor system 'white' blade (S/N 401A) had completely separated from both servo flap brackets (**Figure 31**).⁹ It was reported that when the pilot began to apply collective for a lift, he heard a repetitive "banging" sound, the helicopter began yawing to the left with full right pedal applied, and there was a vertical bounce. The pilot was able to land the helicopter. The left rotor system blades had a CTT of about 1,132 hours at the time of this event.

Figure 31. A separated servo flap from N361KA that was reported to Kaman.

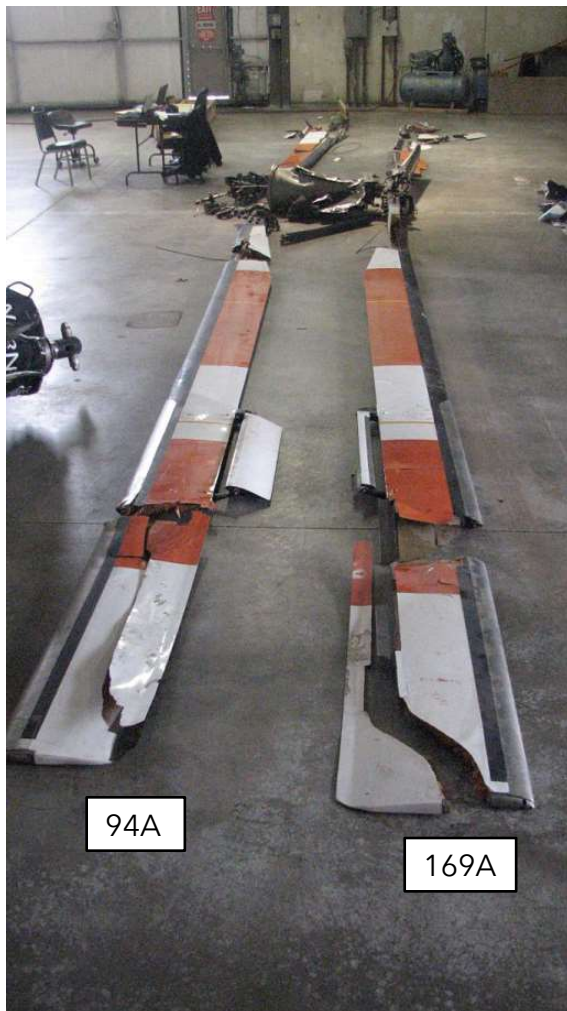
Figure 32. Rotor blade S/Ns 94A (left) and 169A (right)

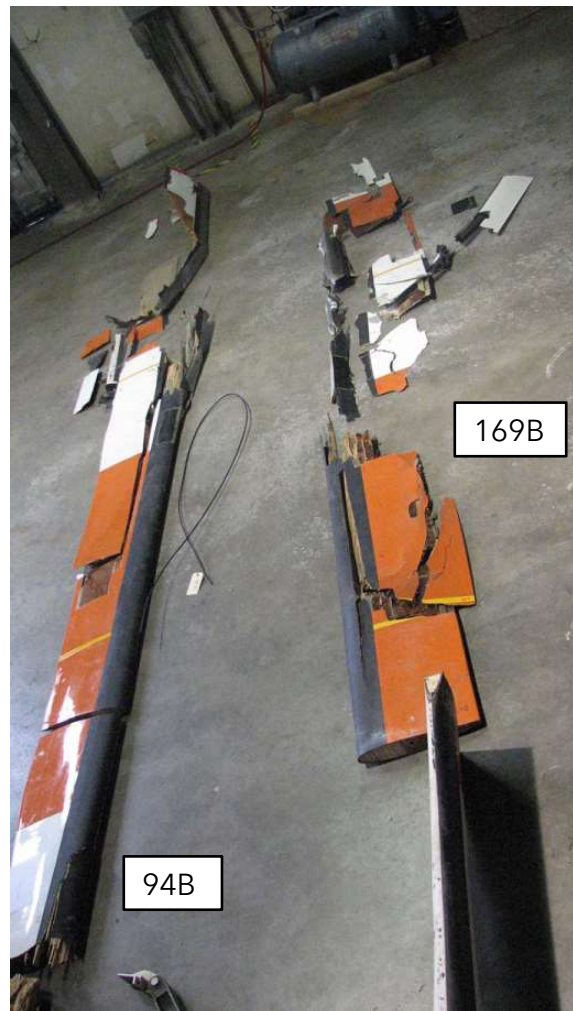
Figure 32. Rotor blade S/Ns 94B (left) and 169B (right)
